"LANDSLIDE INVESTIGATIONS, MAIN NORTH LINE RAILWAY,
SOUTH ISLAND, NEW ZEALAND"

A thesis
submitted in partial fulfilment
of the requirements for the degree
of
Master of Science in Engineering Geology
in the
University of Canterbury

G. Guy Grocott, BSc, BSc (Hons.)

May, 1977

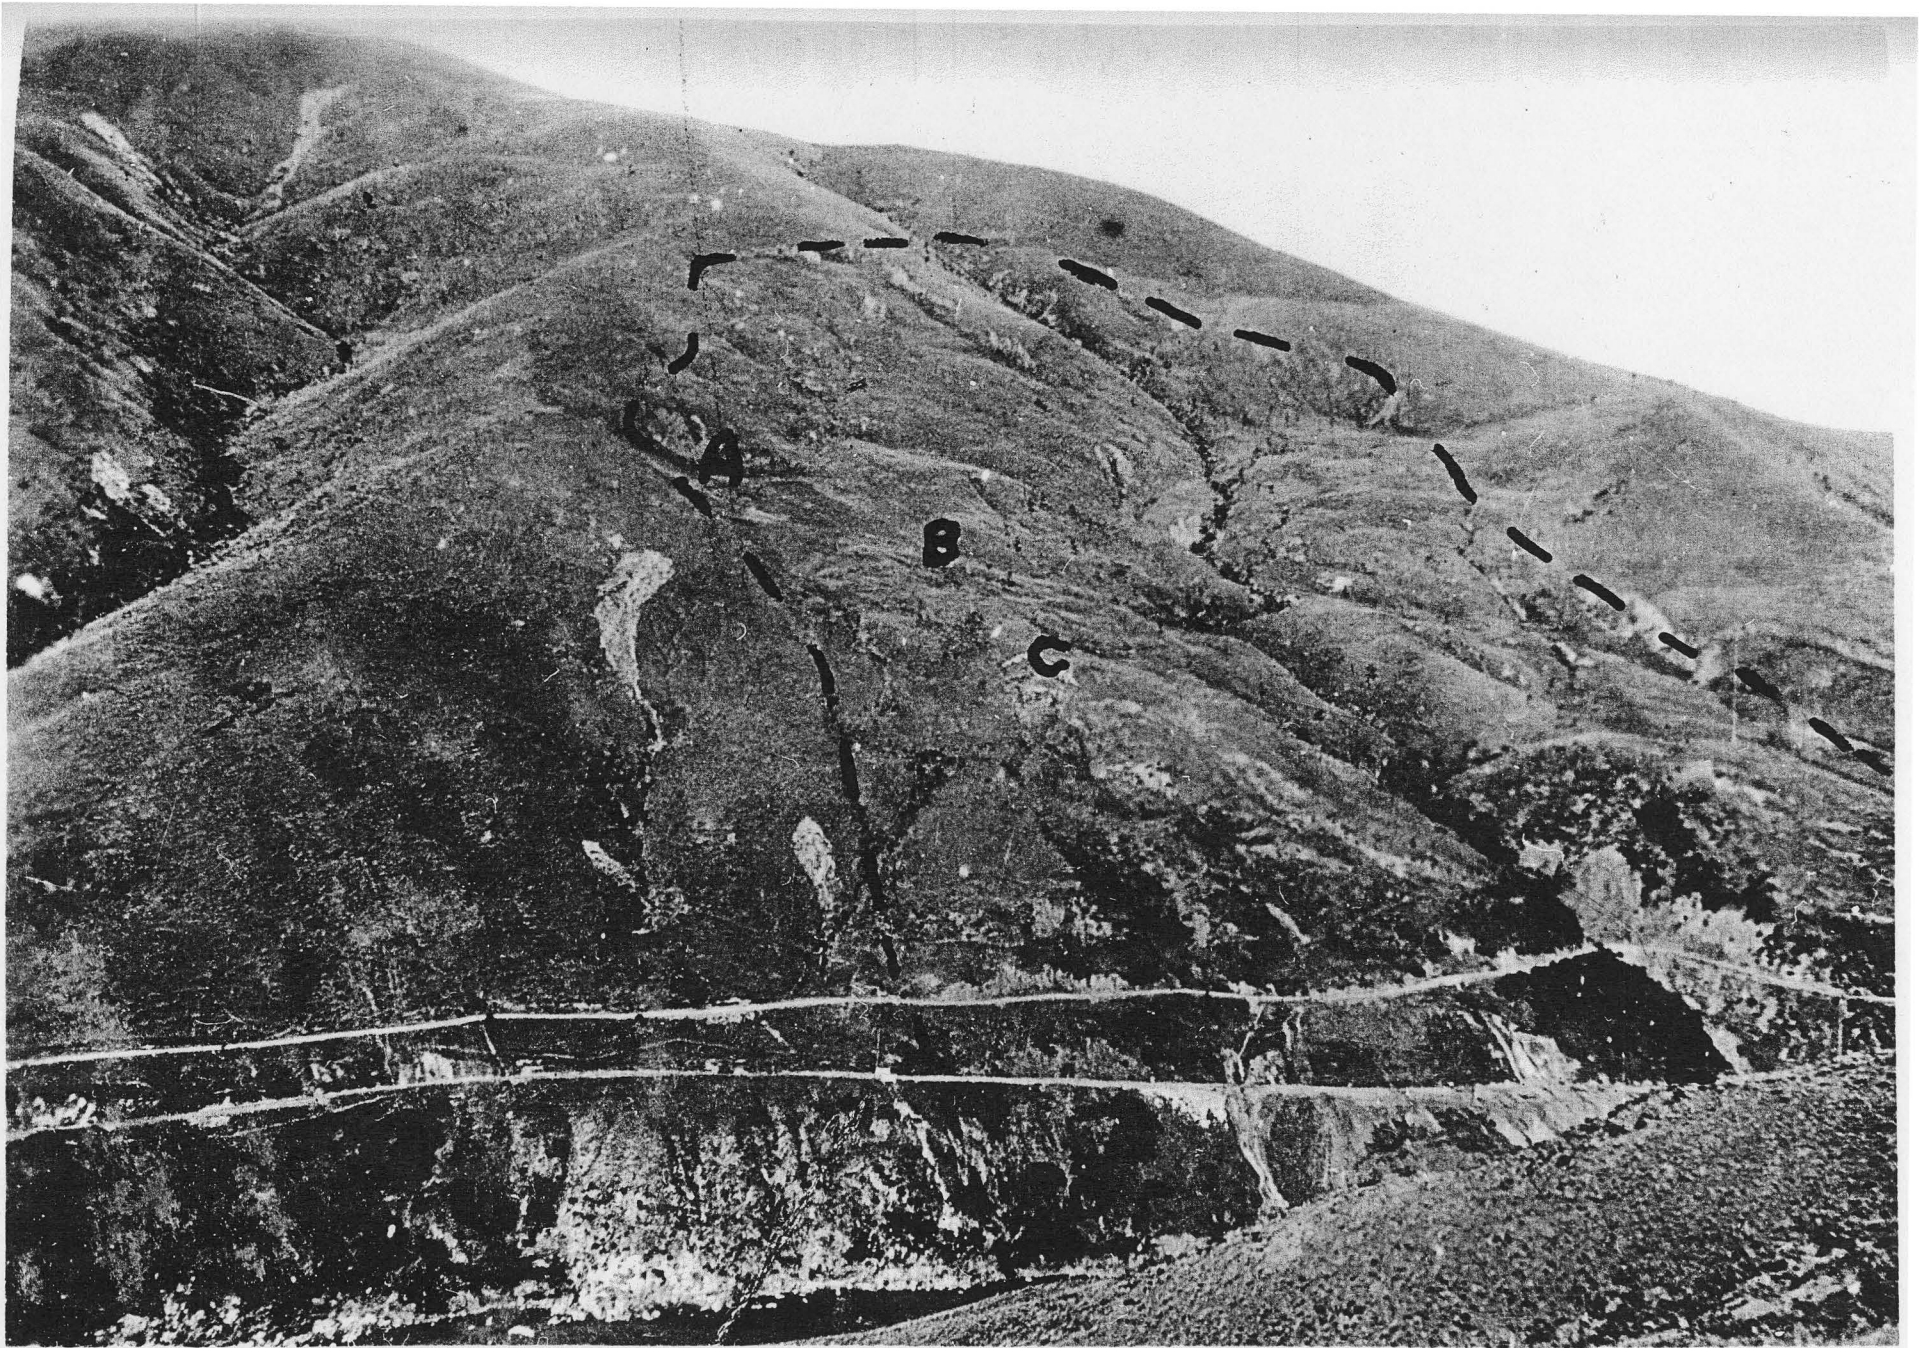
PLATE 1

Plate 1. "A is the rock face with small swampy lagoon at its foot (the rock face and swampy ground is still visible - writer). B is limit of cracks found in the Spring of 1923. C is the top of the main 1923 movement. C-D-E is the area of main movement in 1923", (1923 Railway's files).

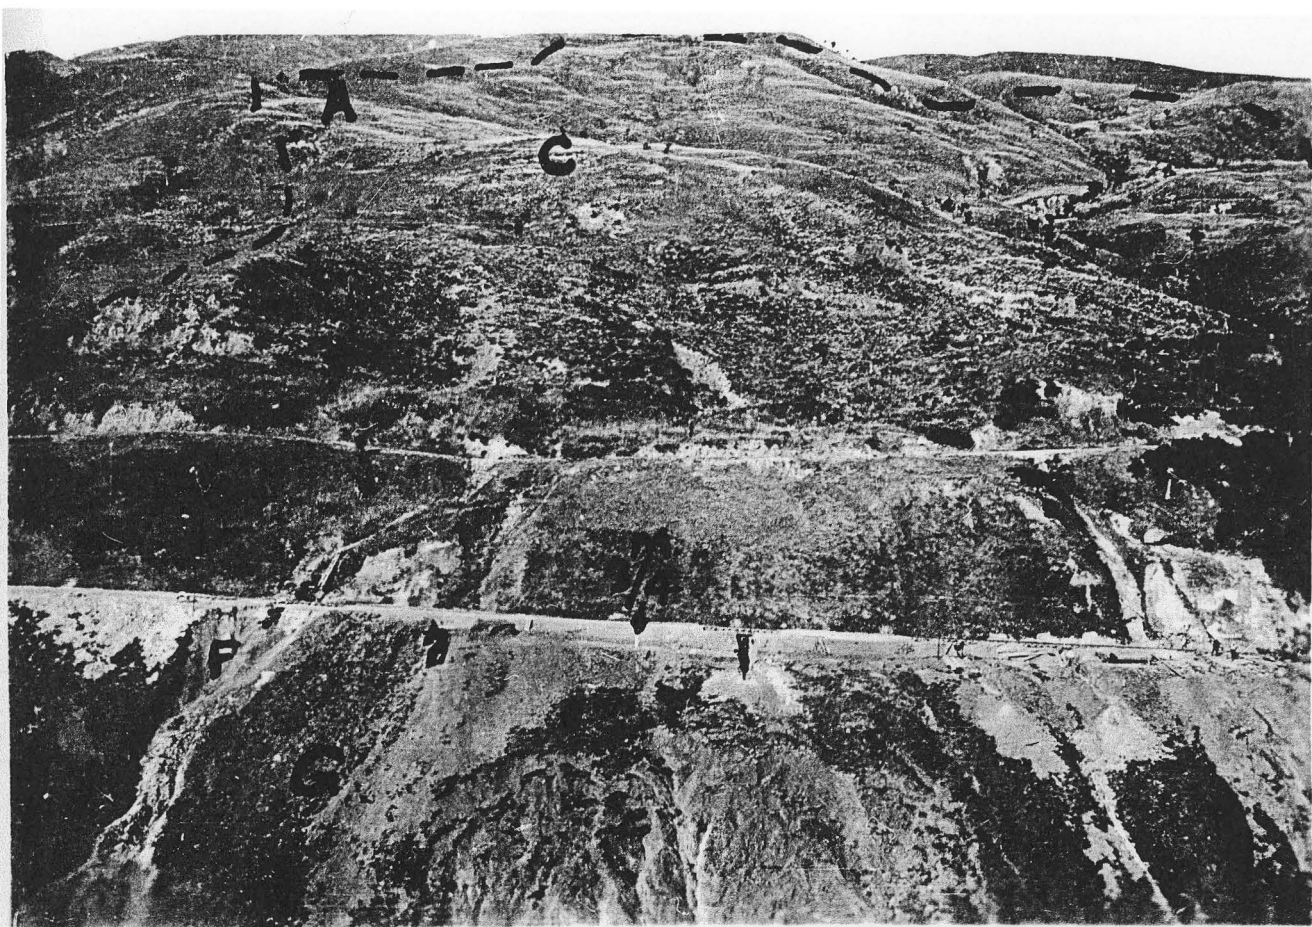
PLATE 2

Plate 2. "F is channel cut out of face of slope and under ends of sleepers", (1923 Railway's files).

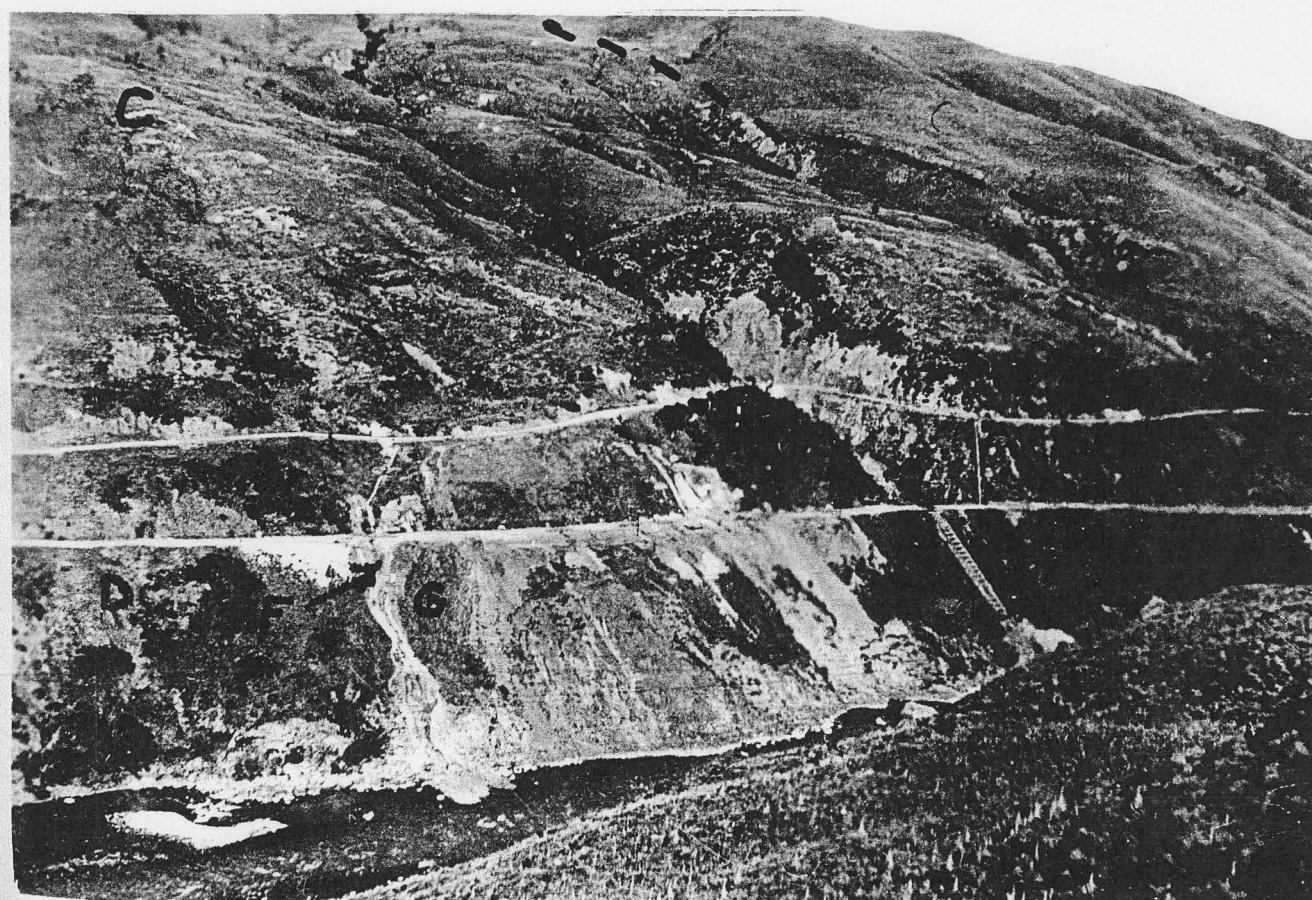
PLATE 3

Plate 3. "C-D-E as before in Plate 1. G-E, face below track is slipping away into river. Track is 190 feet above bed of river. Flood level in May, 1923 was 30 feet above normal water level", (1923 Railway's files).

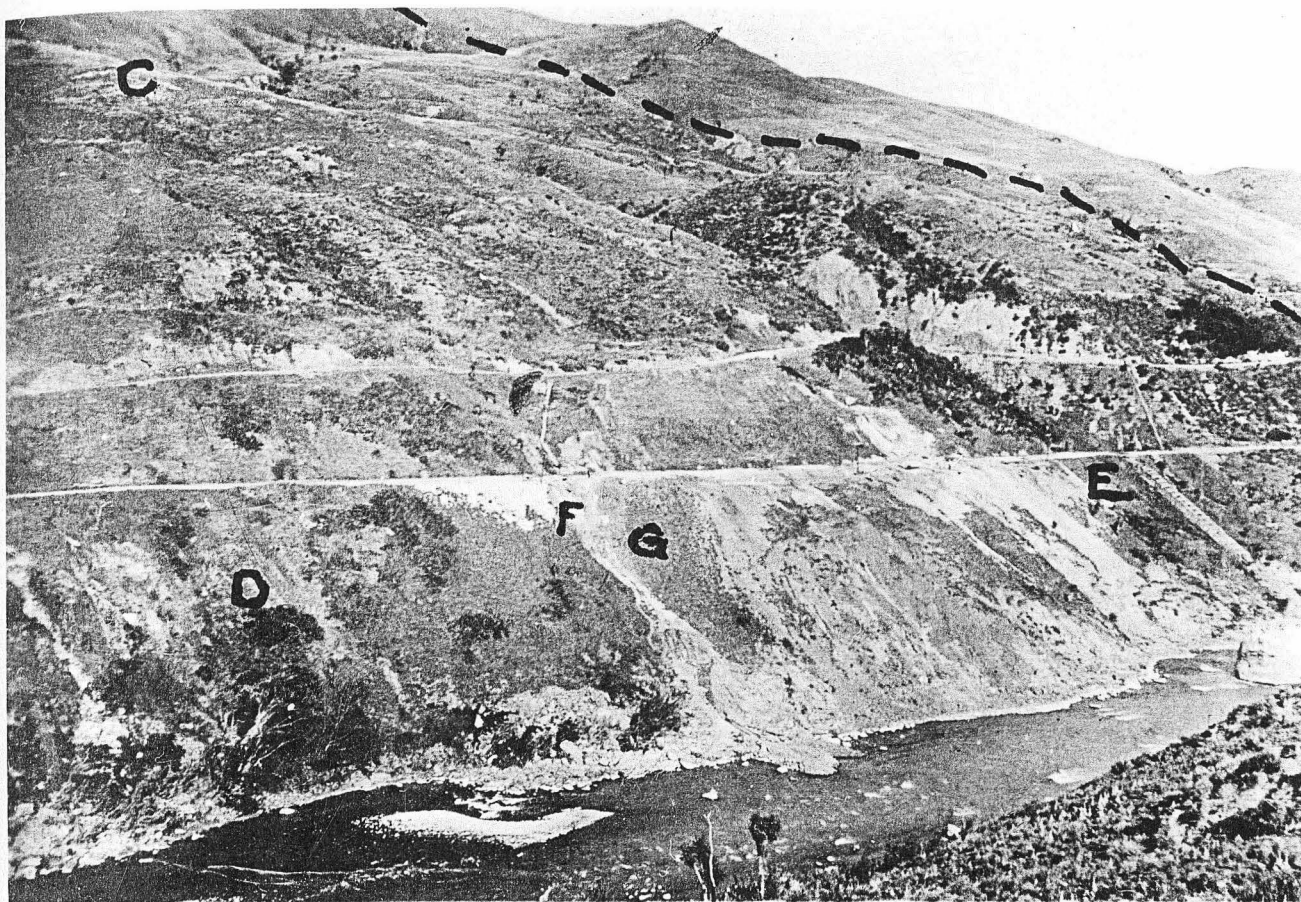
PLATE 4

Plate 4. "From C downwards may be seen the various principal slip faces. These are of varying ages but all comparatively recent", (1923 Railway's files).

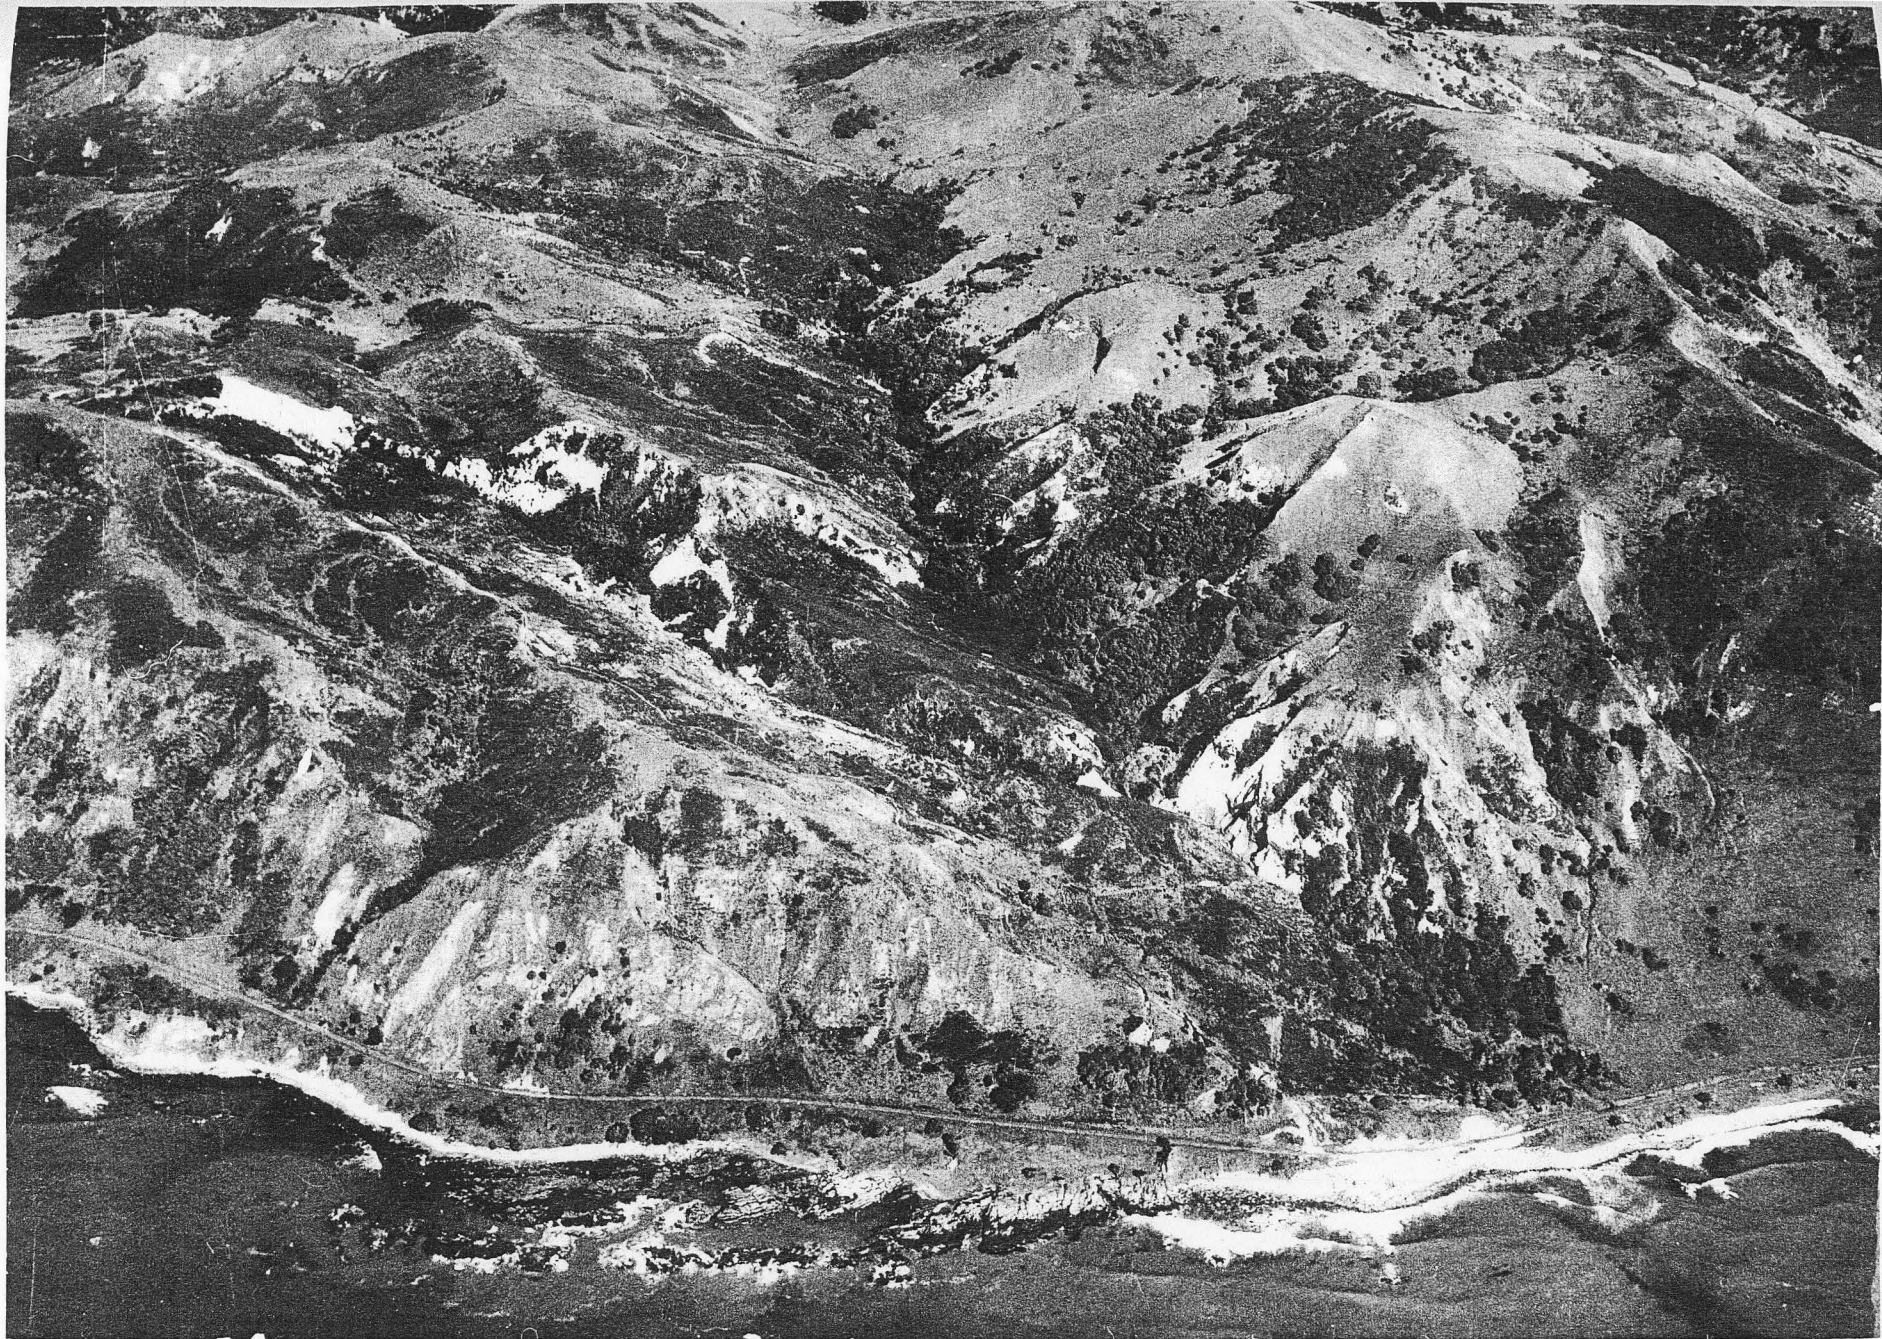
PLATE 7 The Mikonui earthflow. The landslide extends from the left upper centre to the lower right of photograph.

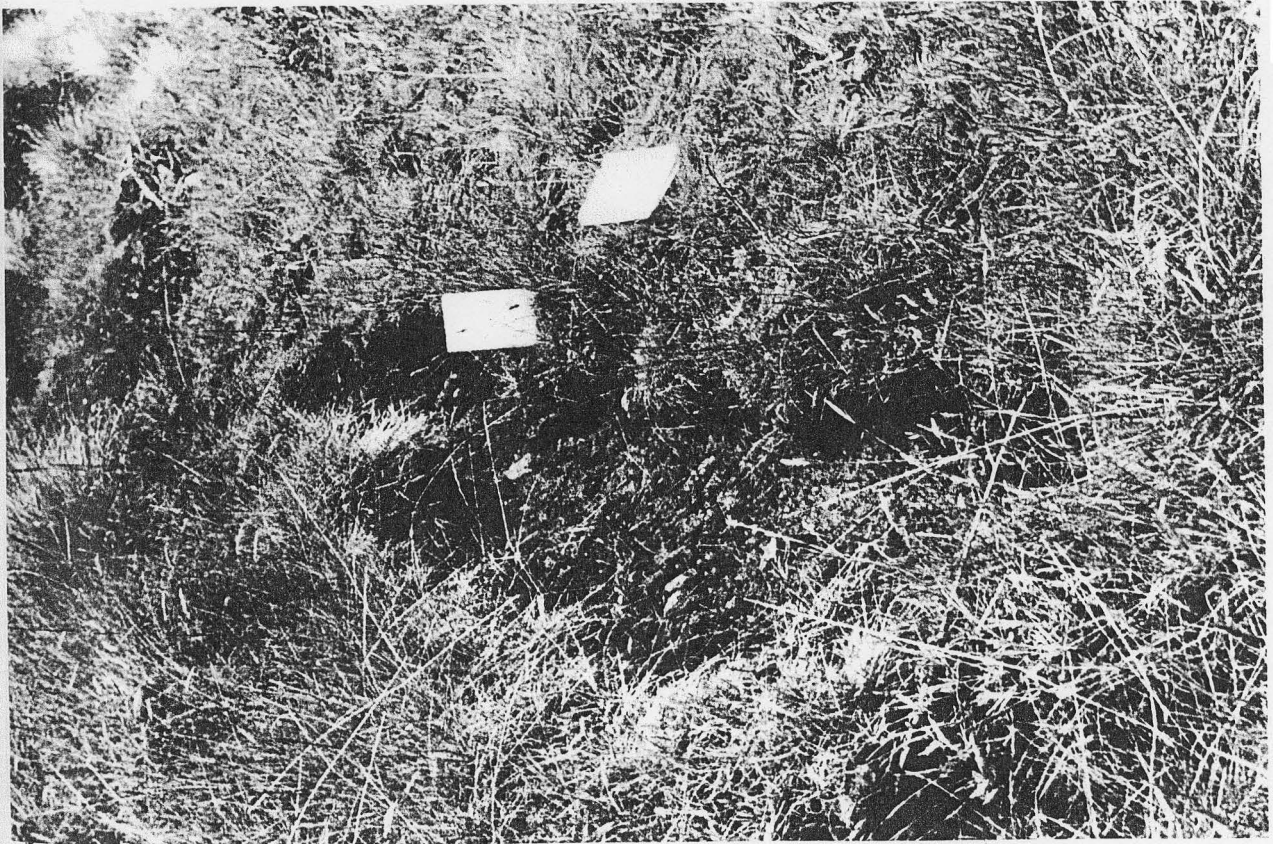
PLATE 10. Tension cracks. Scale is 19cm high.

surface fractures and cracks took place over the winter of 1976 (Plate 10).

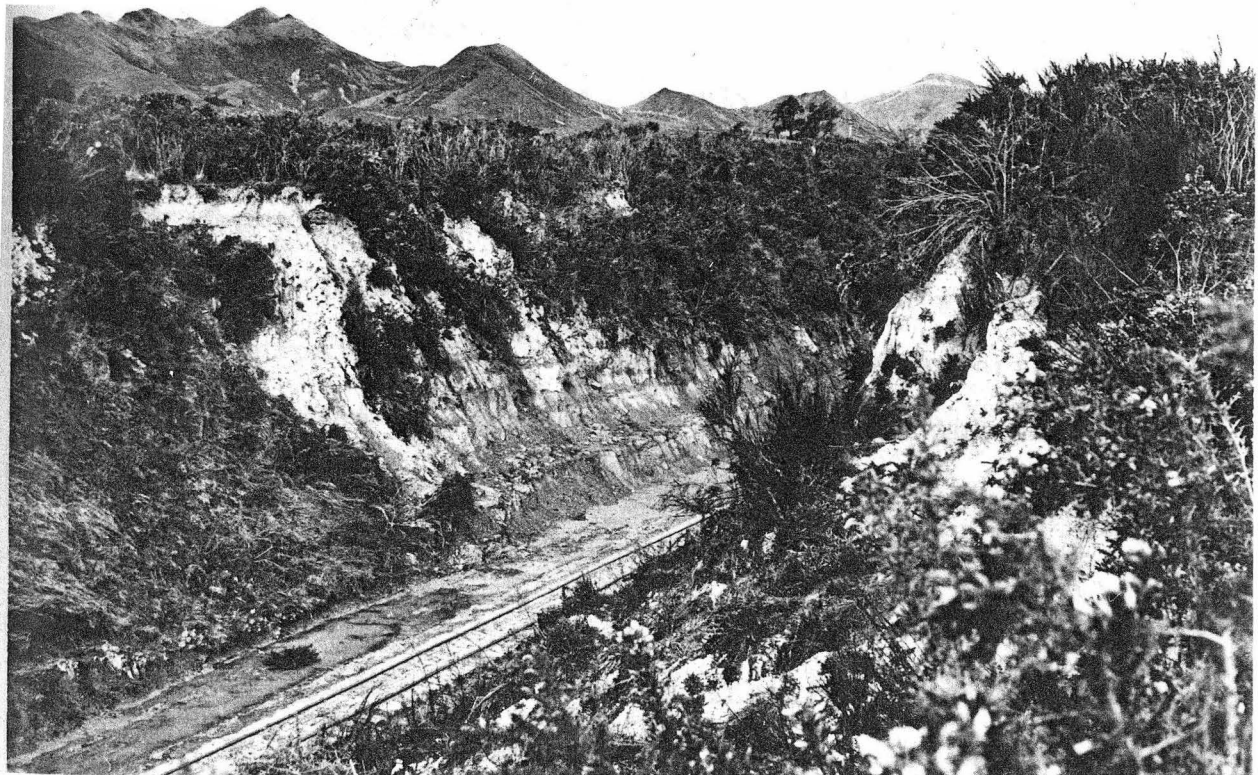
PLATE 12. Batter instability in the Hawkswood Cut.

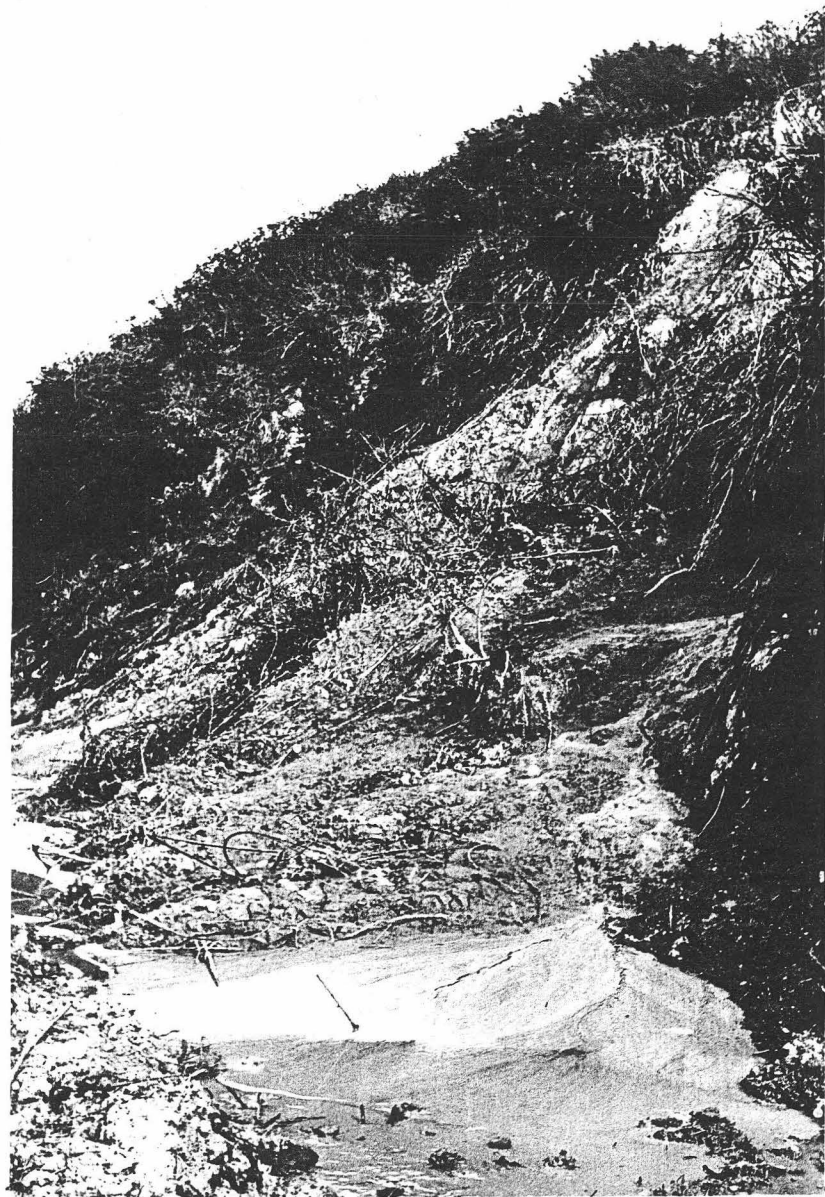
PLATE 15. Earthflow landslide.

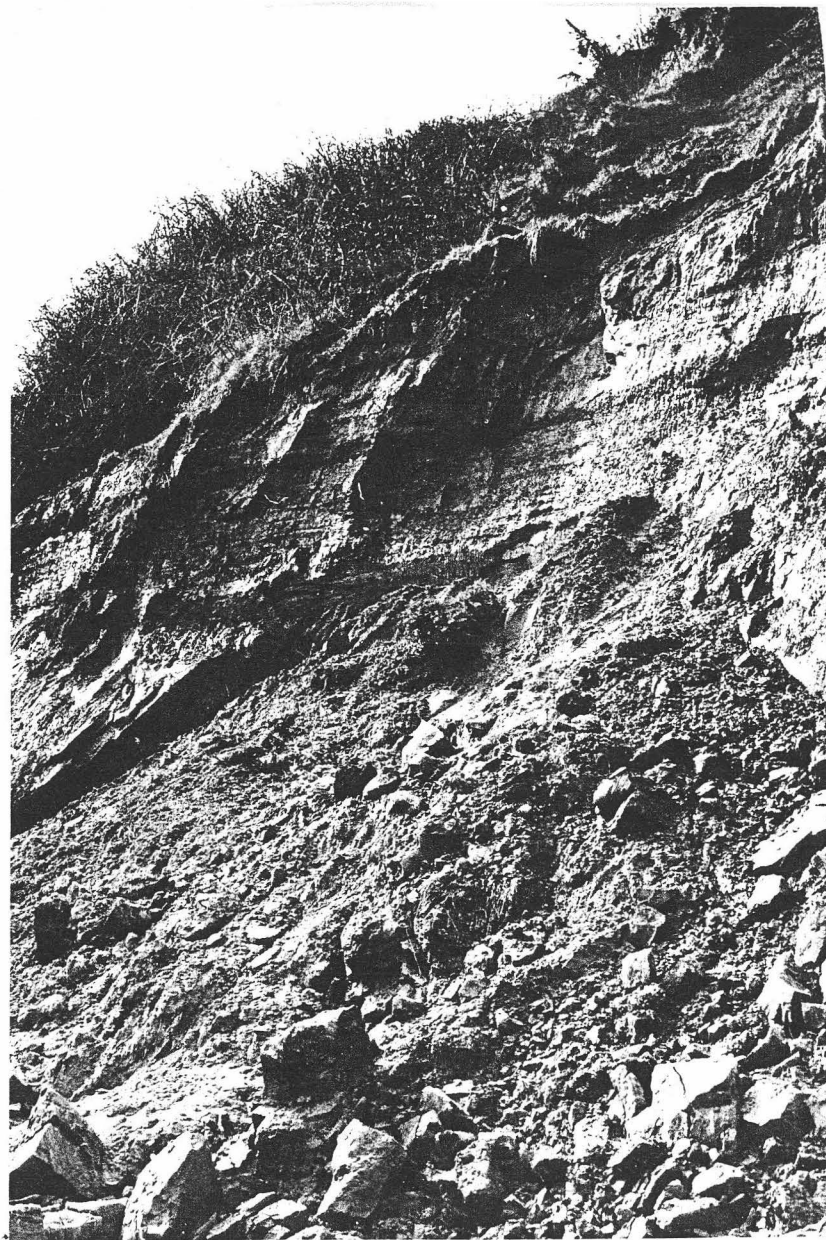
PLATE 14. Earthfall landslides.

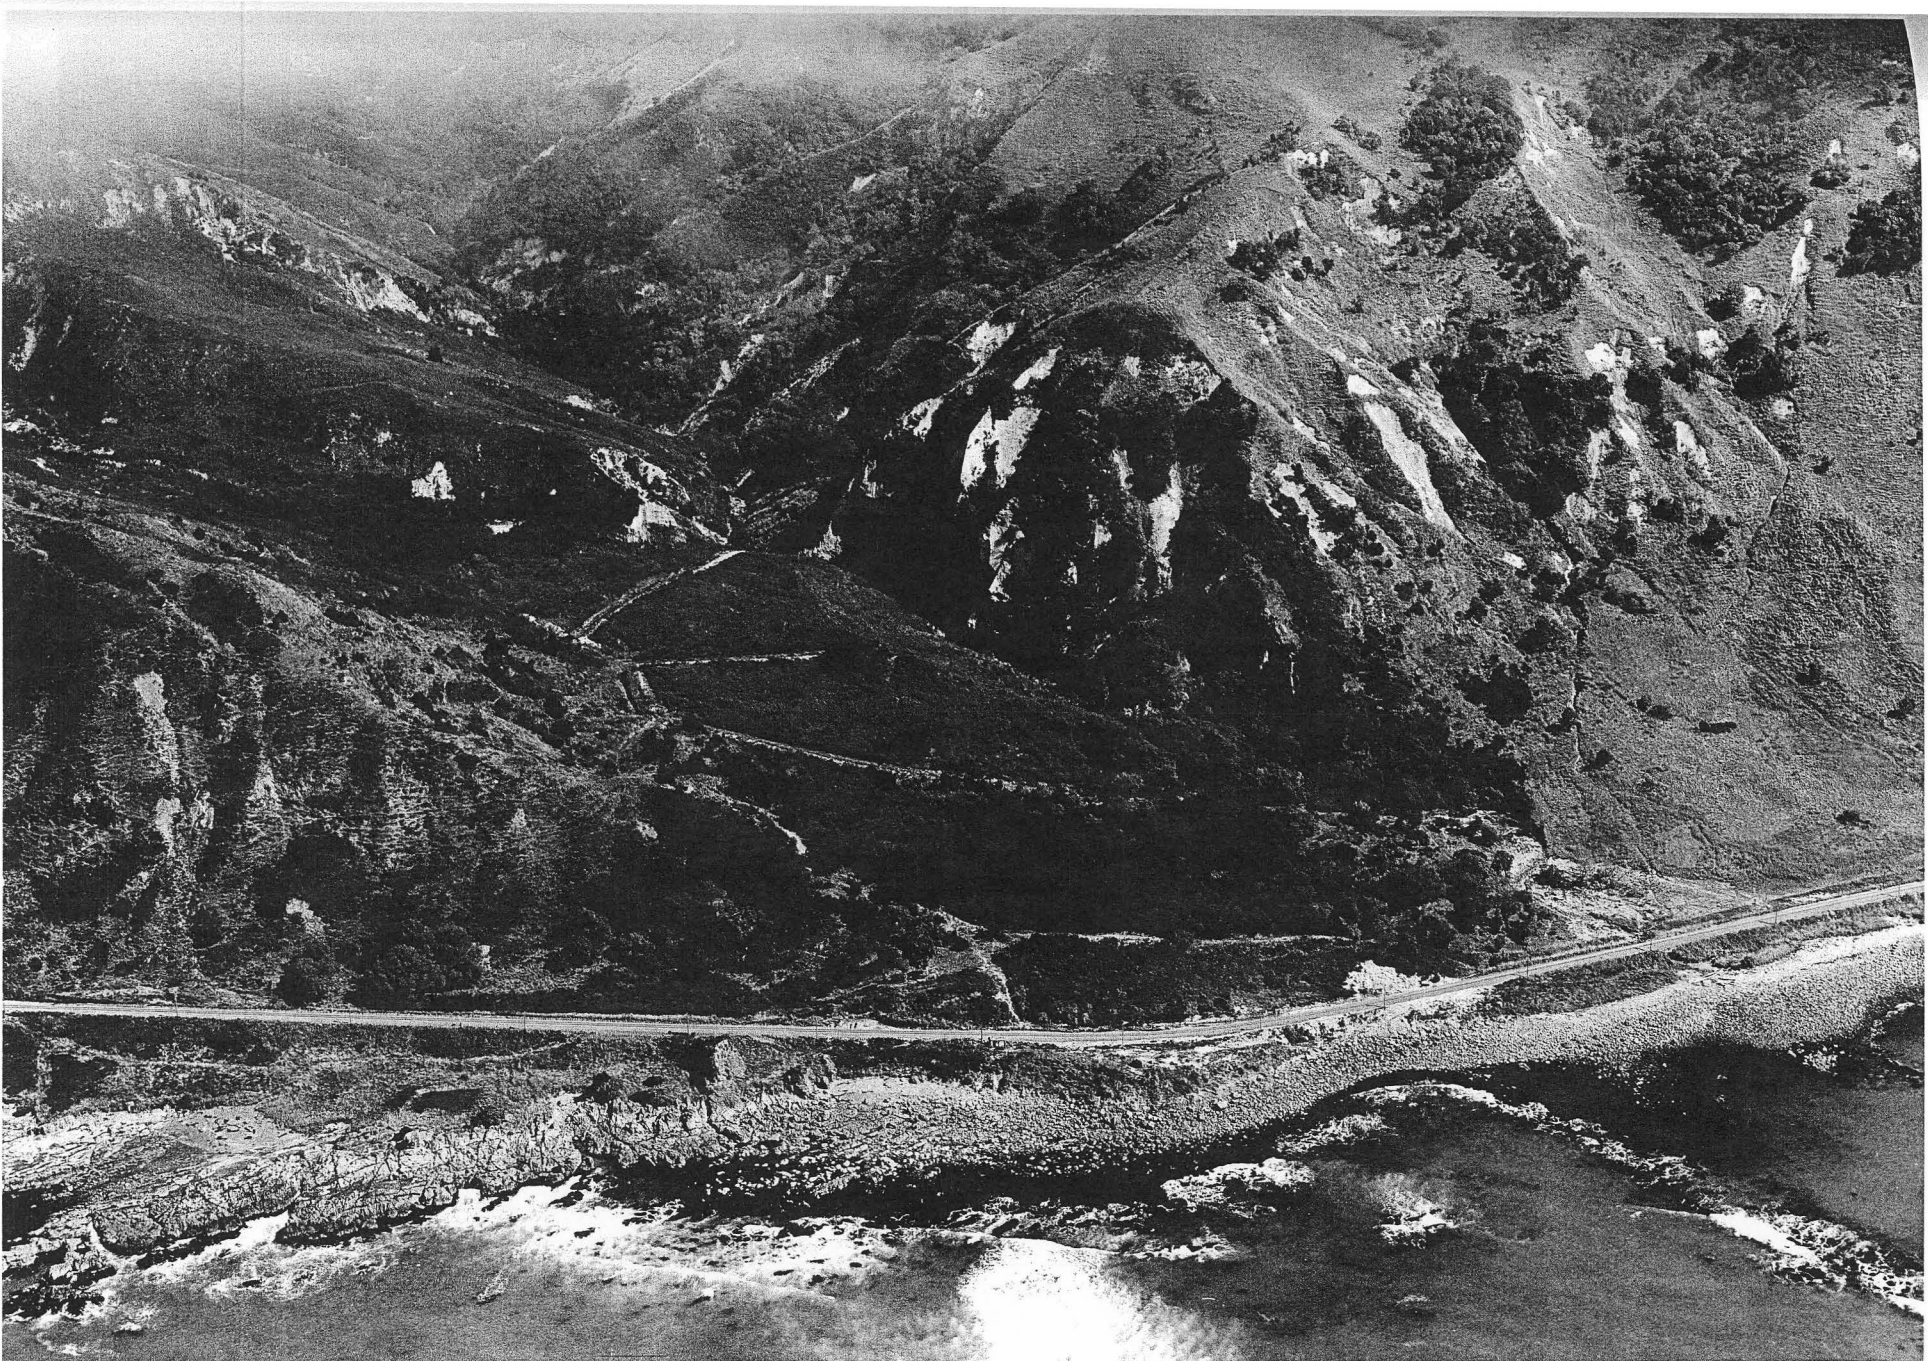
PLATE 17. Surface drains in the lower foot region of the Mikonui earthflow.
(Photograph by courtesy of the N.Z. Geological Survey).

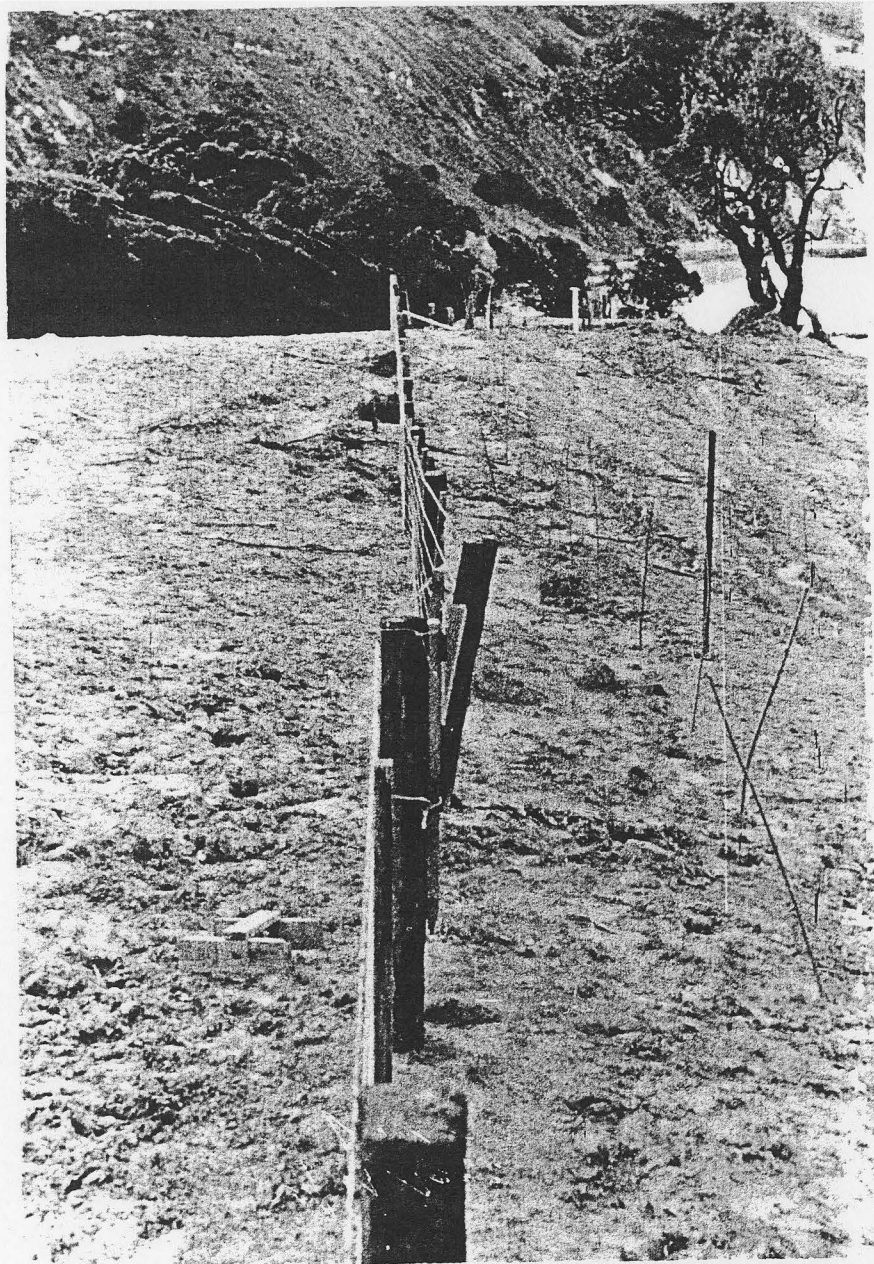
PLATE 19. Recent movement on the Mikonui earthflow illustrated by displaced fence post in centre of photograph.

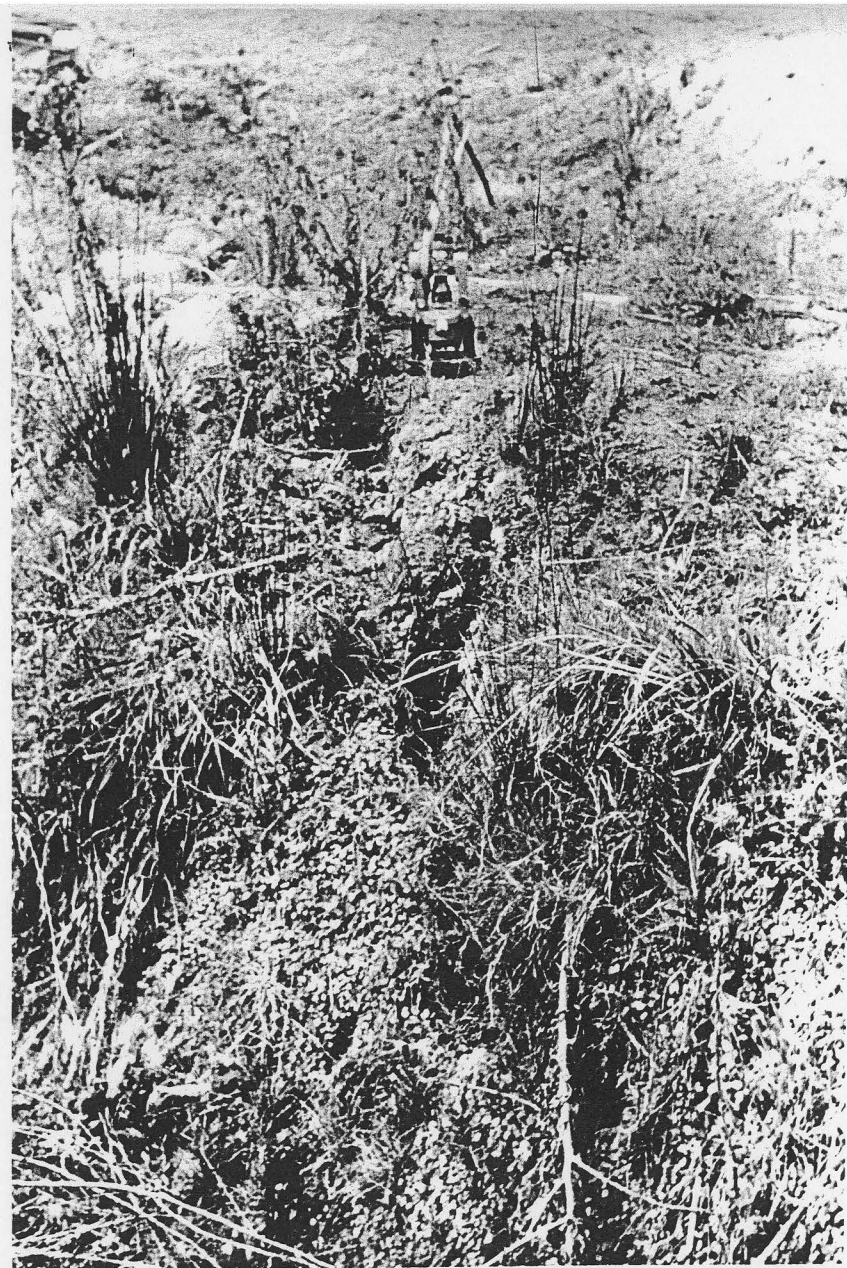
PLATE 18. Shear crack forming discrete boundary of the landslide. Theodolite as scale.
